Navajo Abandoned Uranium Mine

Site Screen Report

NA-0313 AUM Site

Navajo AUM Northern Region

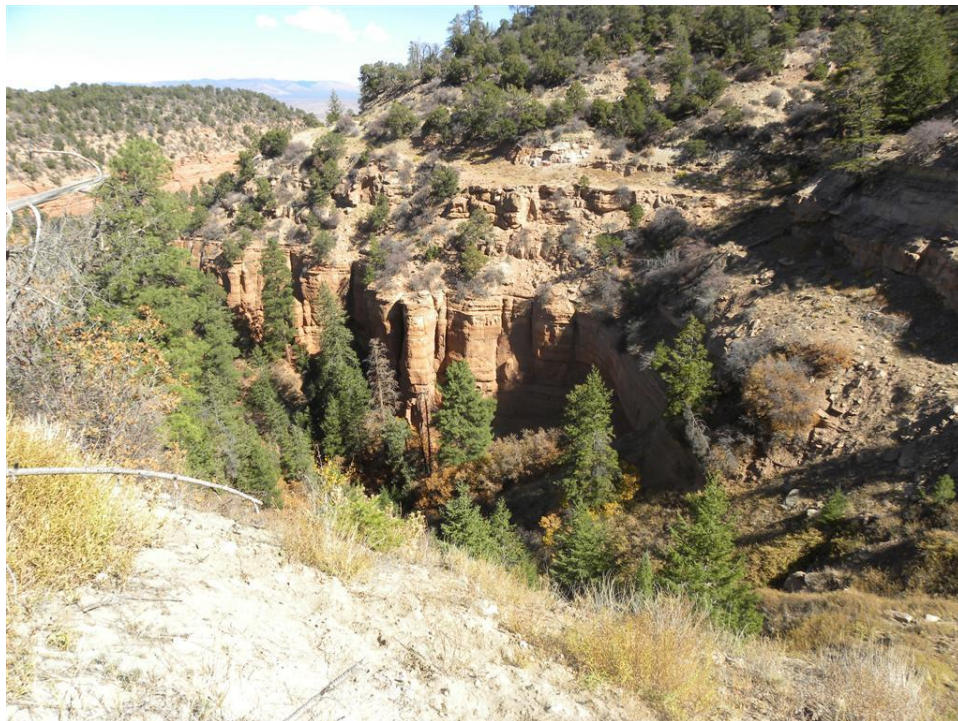
Photo 1. Looking down into mine site

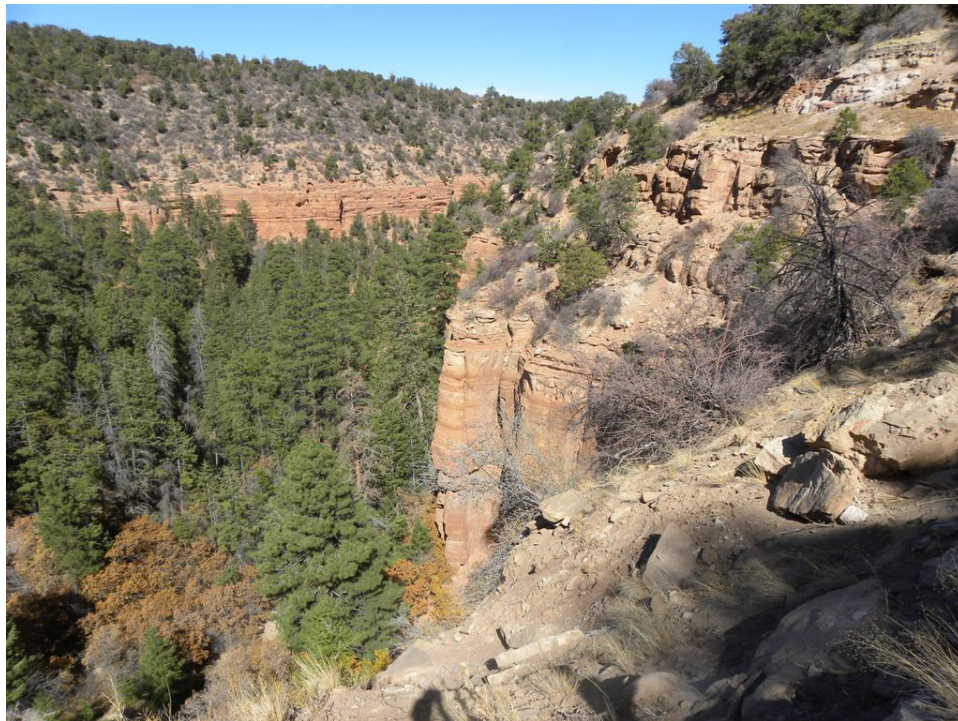
Photo 2. Mine site cliff area

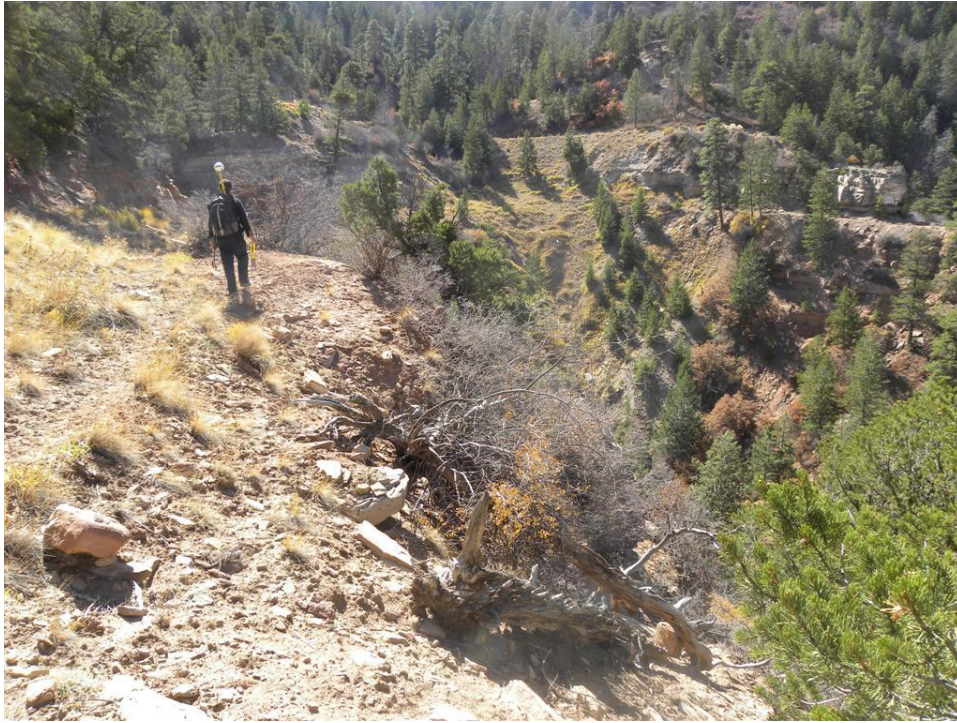
Photo 3. Accessible path on eastern perimeter
